# **NORTHWEST GEOLOGICAL SERVICES, INC.**

**25 August 2020**

**Geological Assessment  
Youth With A Mission Camp  
7085 Battle Creek Rd SE  
8S/3W-25B  
Salem, Oregon**

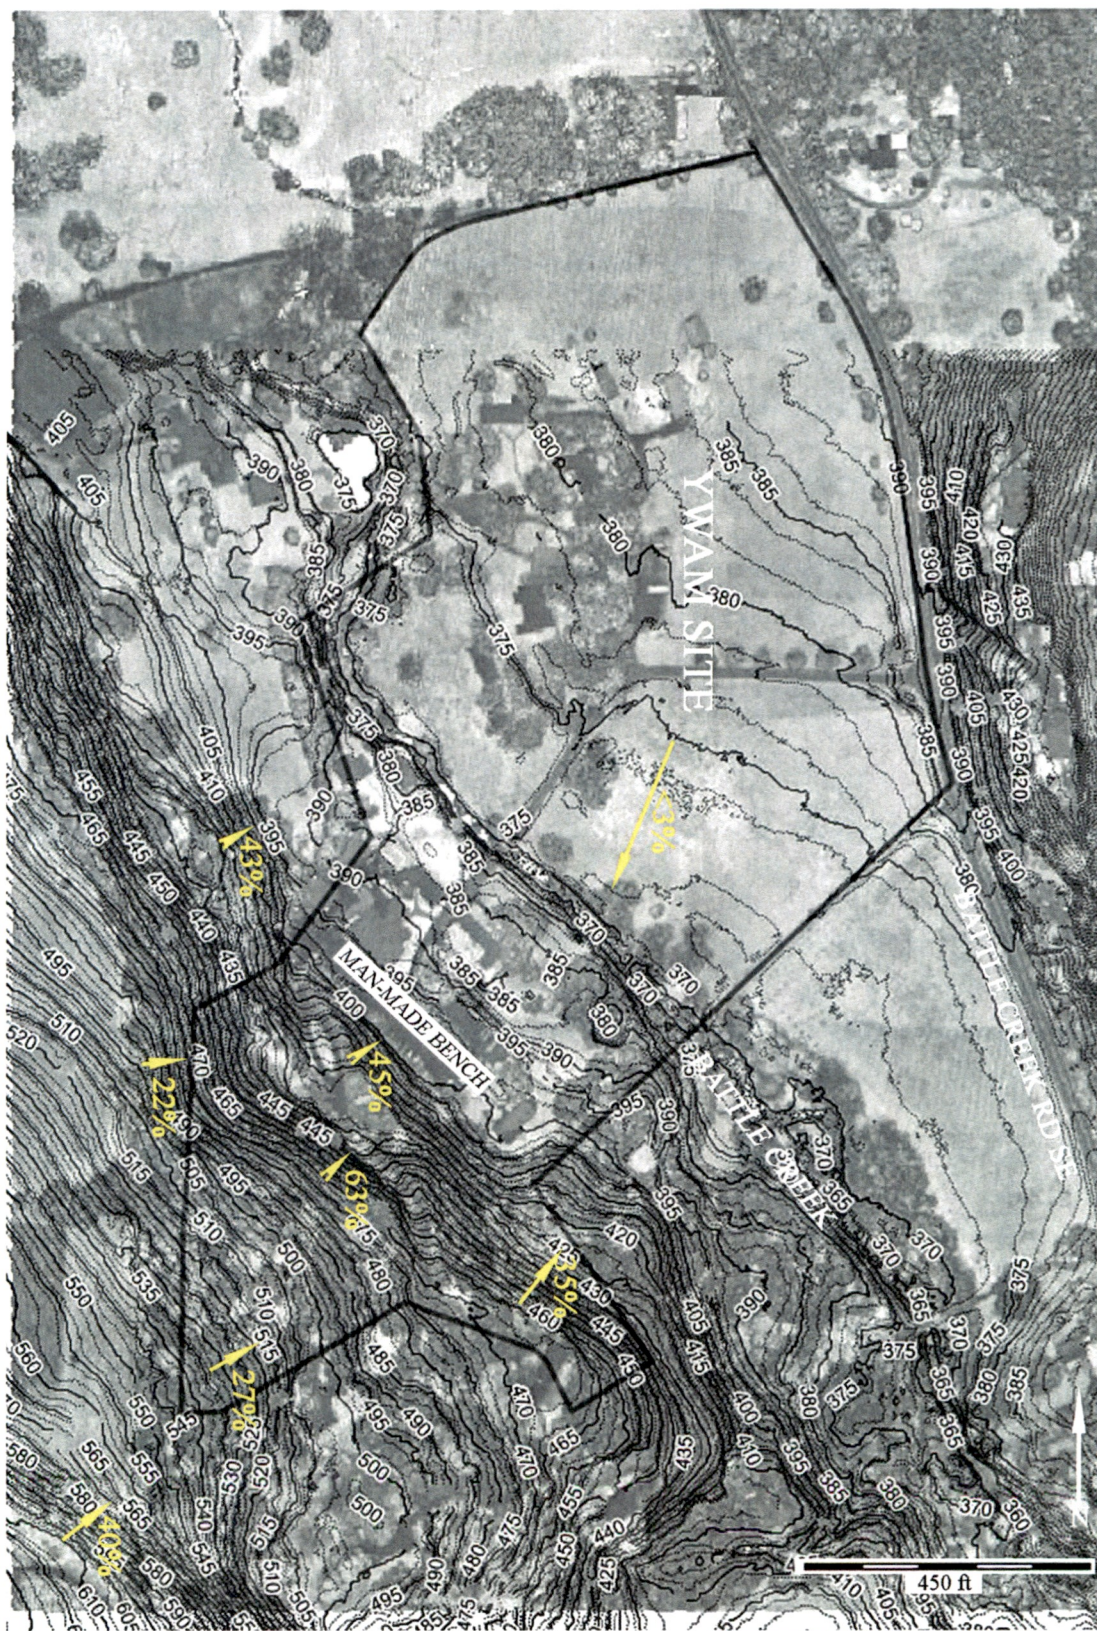
Youth With A Mission		
7085 Battle Creek Rd SE, Salem, OR		
Geologic Assessment		
2018 NOAA LIDAR ELEVATIONS		
NGS, Inc.	August 2020	Figure 3

elevations range from uplands of 500-700 ft elevation down to the Battle Creek floodplain (Figures 1 and 3). The flood plain slopes from 380-390 ft along the margins gently towards the creek that is incised a few feet into the floodplain (Figures 2 and 3). The LIDAR indicates the stream grade falls gently south across the site from 370 to 365 ft (Figure 3).

The east part of the site lies on the Battle Creek floodplain (Figures 2 and 3). The floodplain slopes gently east from Battle Creek Rd towards Battle Creek. West of Battle Creek the site rises to a terrace of old alluvium or Missoula Flood deposits (Figures 3 and 8). Above the floodplain and terrace the site rises towards the SW corner to about elevation 545 ft. The slope continues to rise west of the site to the uplands of 620 ft and higher.

County and State hazards estimates (Section 2.2) rely very heavily on the steepness of surface slopes and generalized assumptions about soils. Consequently, we used the detailed topographic survey (Figure 3) along with our reconnaissance to evaluate slopes and observed eight test pits to assess site soils. The test pits were dug to practical refusal with a tracked excavator that could reach to 10+ ft depth. The test pits sampled each of the geologic settings at the site.<sup>5</sup>

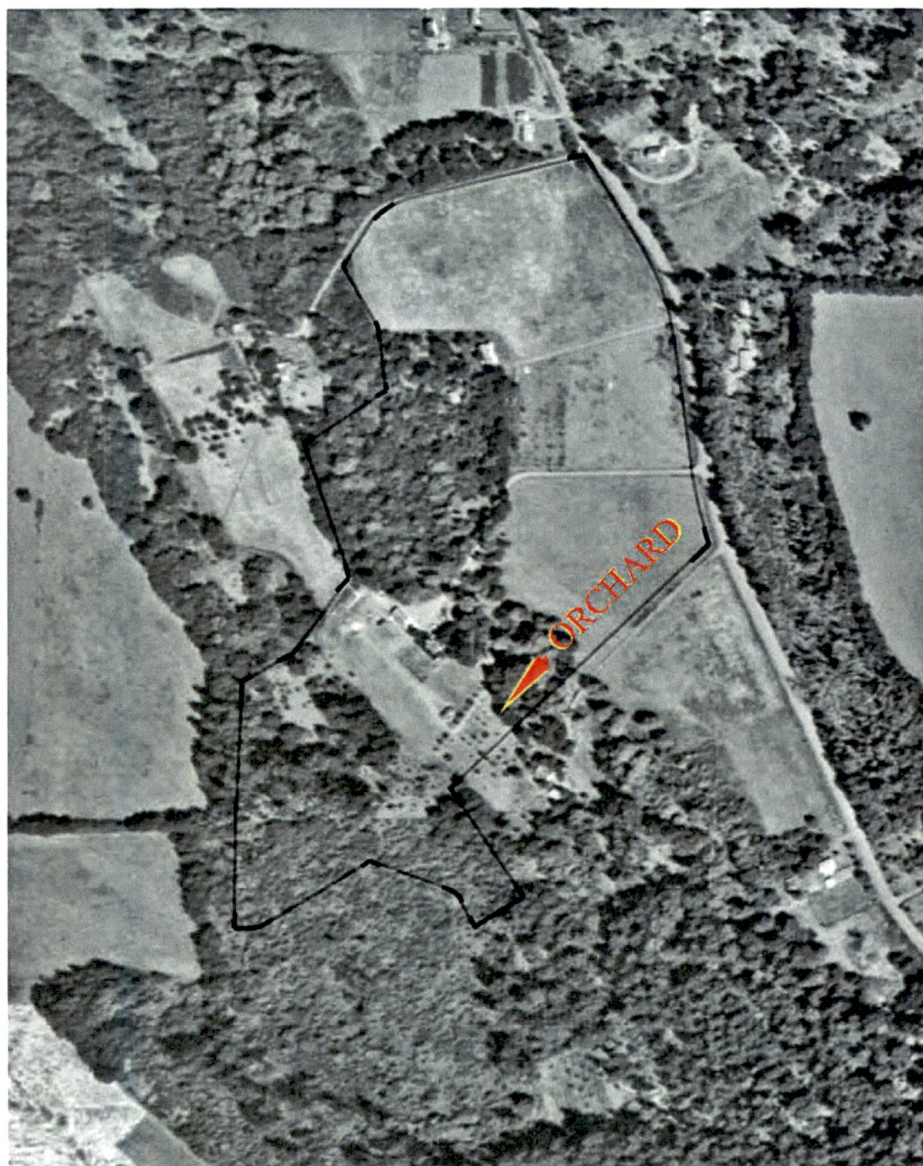
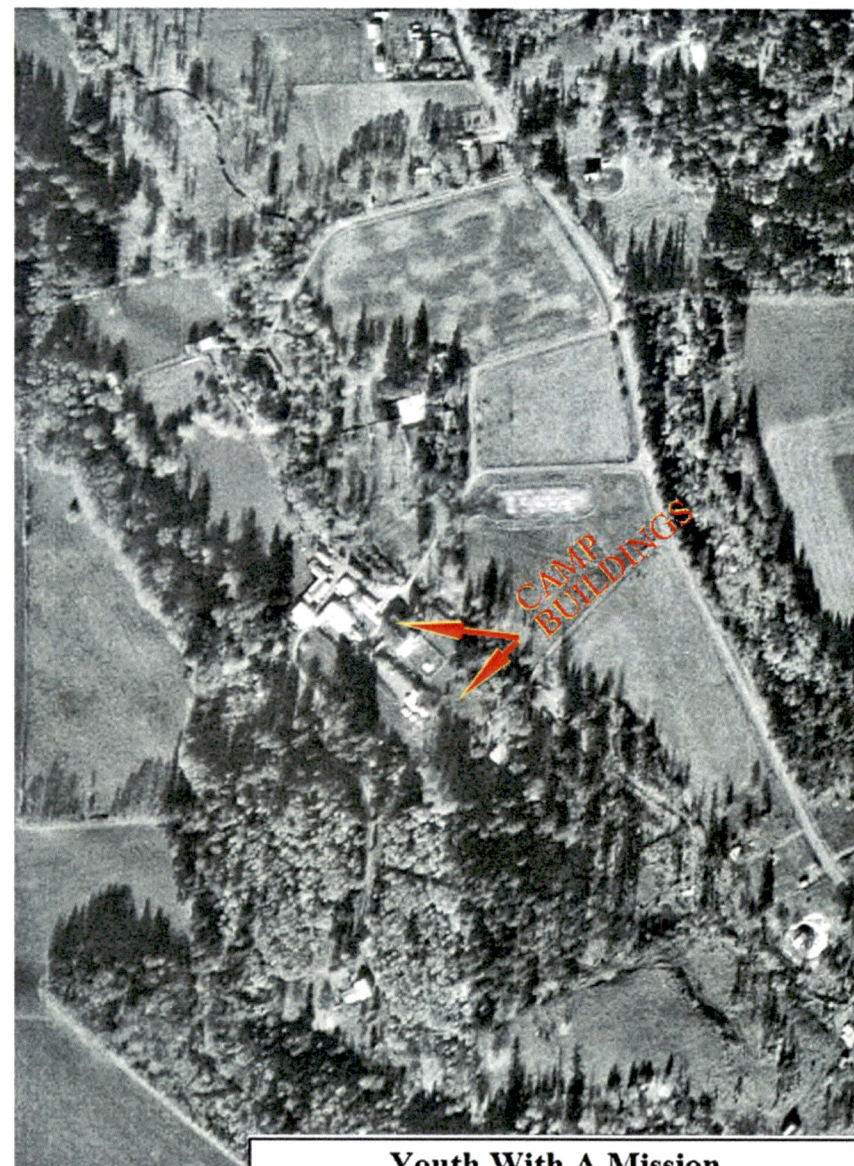
Youth With A Mission		
7085 Battle Creek Rd SE, Salem, OR		
Geologic Assessment		
Historic Aerial Photos		
NGS, Inc.	August 2020	Figure 4

Historic maps and aerial photos indicate that the site was forest, farmland and orchard through the 1950s (Figure 4, left). County records show the original farm house and barns were built in 1940. However, the 1915 USGS Sidney quadrangle shows a structure at the NW part of the site. The 1967 aerial photo shows that the orchard was replaced by several structures and the stream terrace was widened (Figure 4, right and Figure 3, Man-made bench). Figure 5 shows the current configuration of the camp and the proposed additions and refurbishing. Figure 6 shows the east part of the site with the nearly-flat gentle slope towards Battle Creek.

The maps and photos show that the site has a long history of rural agricultural use. The 1954 and 1967 aerial photos (e.g., Figure 4) show the site as pasture, orchard and woods. The 1967 photo shows the orchard replaced by structures. Later aerial photos and images show addition of the structures that make up the camp.

No signs of slope instability or failure were observed on the aerial photographs we examined. The resolution of the aerial photos is adequate to see vehicles on roads and relatively minor earthworks. Consequently, we believe that any significant slope failure should be identifiable on the photos we reviewed.

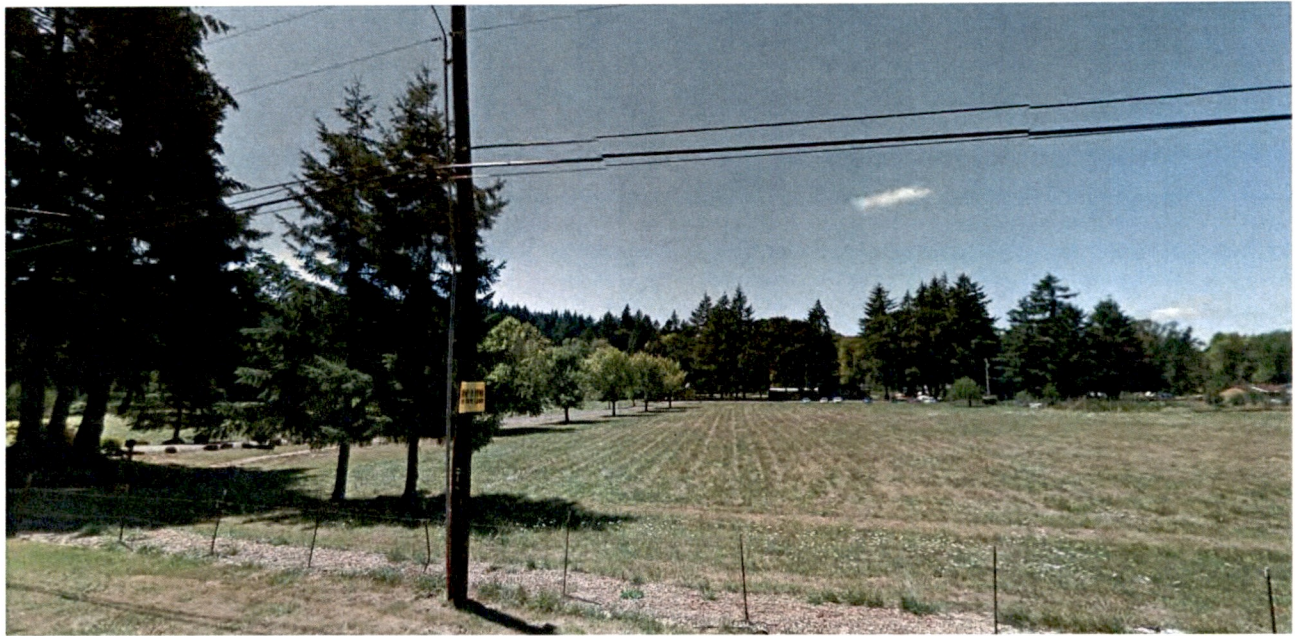
ABOVE: View west from Battle Creek Rd SE across the NE part of site. Entrance road on left. Conifer grove at right center is location of original 1940s farm buildings.

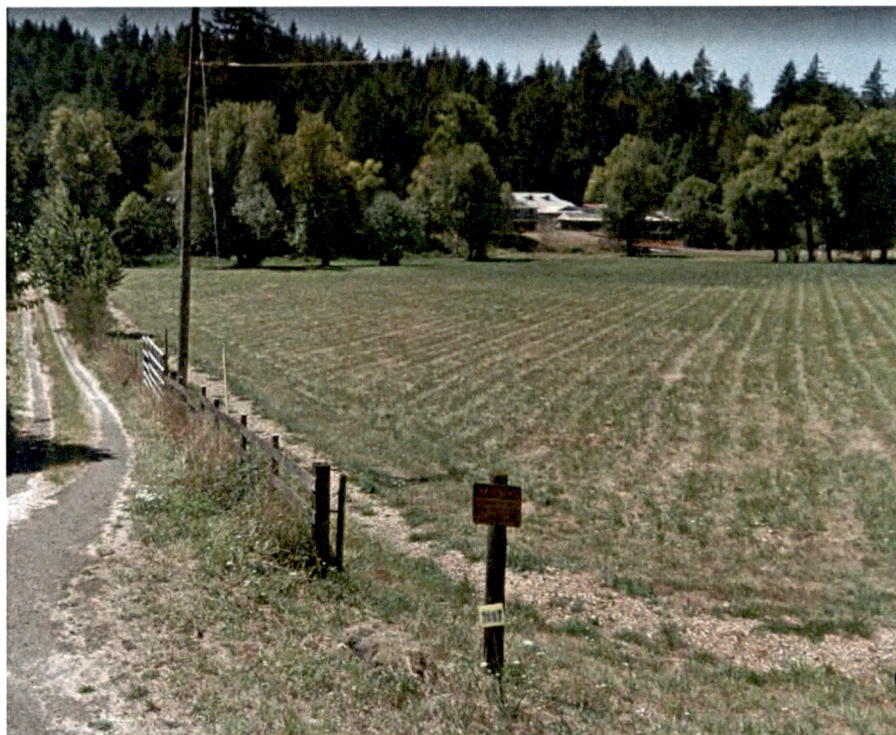
LEFT: View WSW from Battle Creek Rd SE across SE part of site. Diveway to property south of site at left. Existing dormitories at center and forested hillside in background.

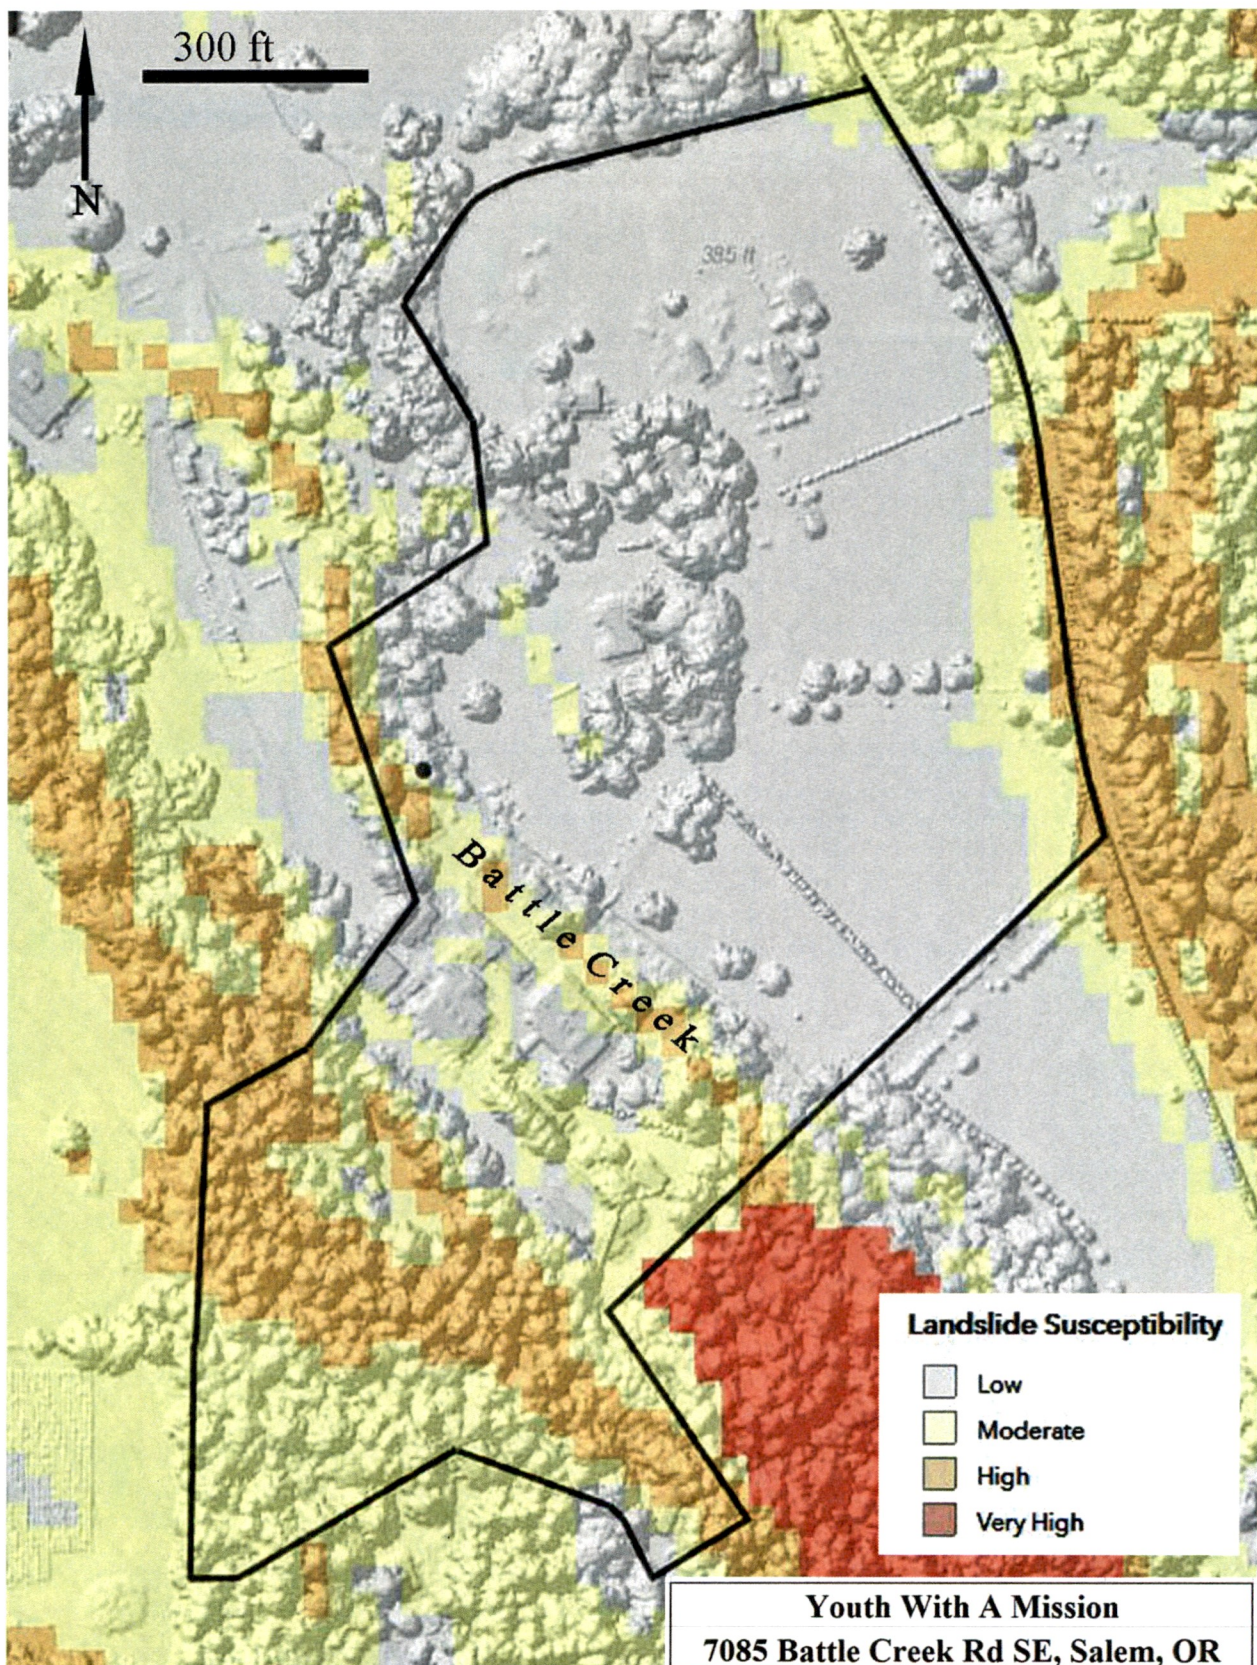
Youth With A Mission		
7085 Battle Creek Rd SE, Salem, OR		
Geologic Assessment		
SLIDO Landslide Susceptibility		
NGS, Inc.	August 2020	Figure 7

The State online hazard database, SLIDO, shows no historic or active landslides at the site. However, SLIDO shows a "mapped landslide" immediately south of the site.<sup>1</sup> SLIDO shows that area as "Very High" risk in the Landslide Susceptibility layer (Figure 7). Flat areas of the site (e.g., area shown on Figure 6) are shown as low or moderate risk. Gentle and moderate slopes (are interpreted by SLIDO to have "Moderate" to "High" risk of landsliding, respectively.<sup>2</sup>

<sup>2</sup> Away from mapped landslides, SLIDO estimates landslide susceptibility mostly from slope angle determined from topographic maps, USGS Digital Elevation Models or LIDAR-determined slope angle (compare figure 3 and 7).

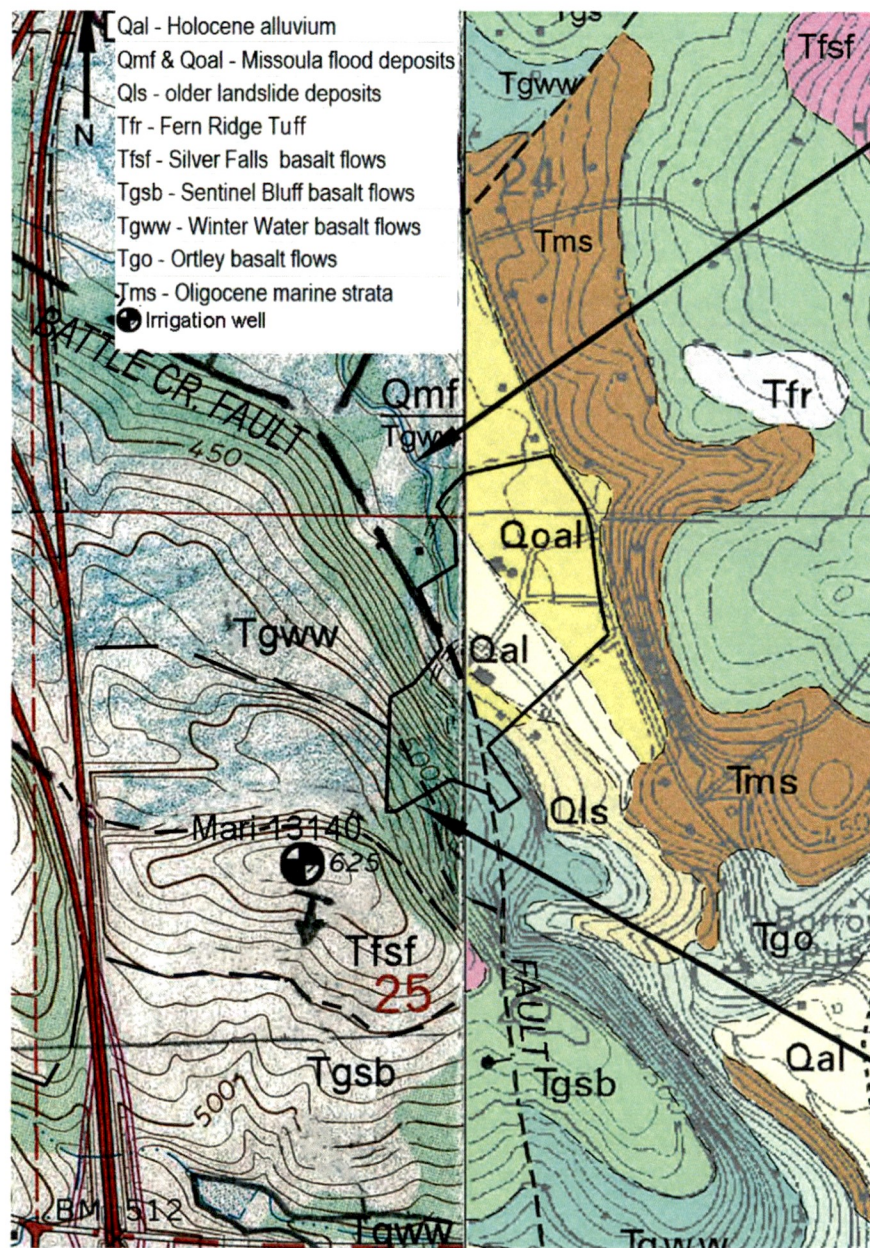
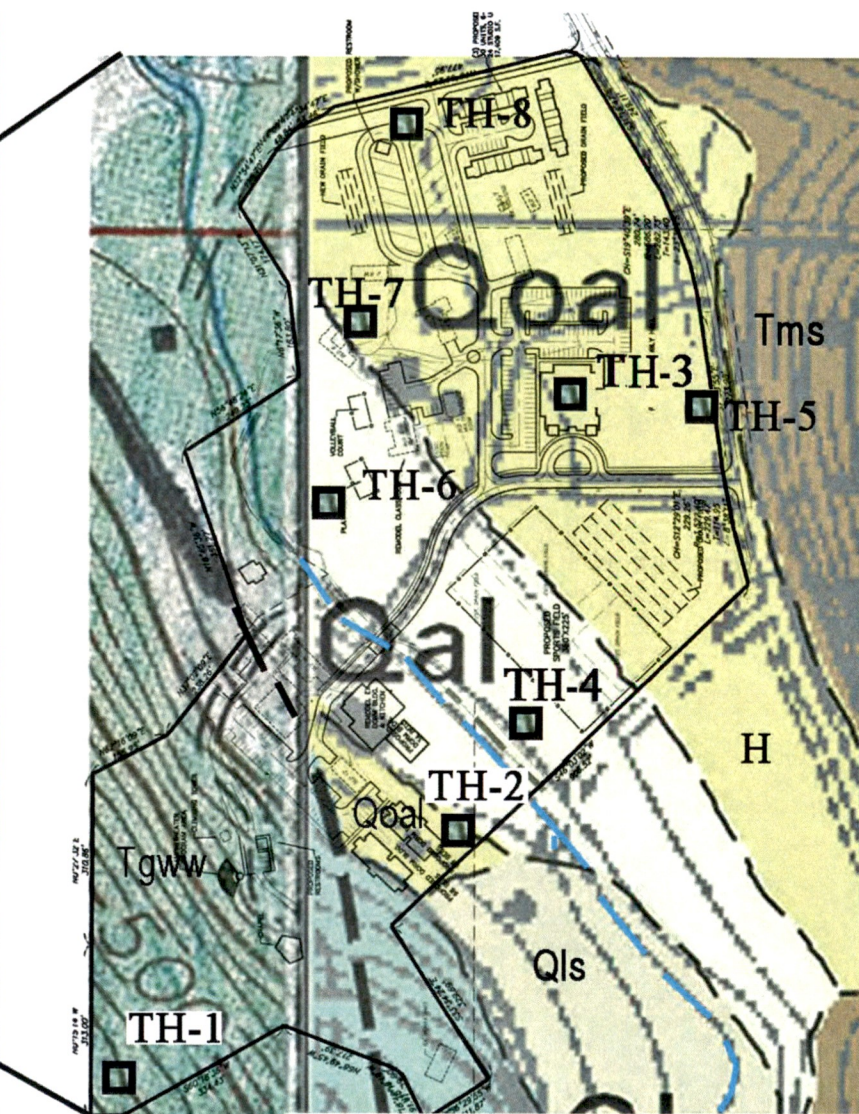
Youth With A Mission		
7085 Battle Creek Rd SE, Salem, OR		
Geologic Assessment		
NGS & USGS Geologic Maps		
NGS, Inc.	August 2020	Figure 8

**WEATHERED BASALT:** Test pit TH-1 sampled the weathered basalt beneath the slopes of the west part of the site, near the camp reservoir (Tgww, Figure 8). Below 1 ft of topsoil, it found red-brown, moist, sandy, clayey SILT that graded down from medium stiff to stiff. The SILT has the texture of severely weathered vesicular basalt with clay-filled relict vesicles and ghost crystal outlines.

**OLDER ALLUVIUM:** Test pit TH-2 sampled the old alluvial terrace deposit (Qoal) above the south bank of Battle Creek. It was dug as close as feasible to the part of the terrace mapped as landslide south of the site (Qls, Figure 8). Below 1 ft of topsoil, the terrace was composed of 4 ft of red-brown, very moist, sandy, clayey SILT that graded downwards to medium stiff. Below that the Qoal was red brown and reddish tan gritty SILT to clayey silty SAND with abundant carbonized leaf and twig fragments. When dry the deposit is hard, but in-situ it was moist and medium stiff to medium dense. There was no evidence of shearing, breccia or landslide texture in TP-2.

Test pits TH-3, -5, -7 and -8 sampled the Qoal, (Figure 8) in the flat part of the site east of Battle Creek. The sediments in TH-3 were medium to stiff tan to brown sandy clayey SILT with thin local red-brown layers of silty CLAY. The SILT has relict texture of pebbly silty SAND. In TH-3 the Qoal was crudely bedded with the layers of brown SILT separate by thin bands of the reddish tan SILT. These are interpreted to be alluvial channel deposits separated by thin slack water silty clay.

**ALLUVIUM:** Test pits TH-4 and -6 sampled the area along the east bank of Battle Creek mapped as alluvium (Qal, Figure 8). However, samples at 4 ft (TH-4) to 4.5 ft (TH-6) found medium dense to dense weathered grey to light brown gritty silty SANDSTONE.<sup>6</sup> The excavator reached practical refusal at 1.5 to 3 ft into the SANDSTONE.

We interpret the weathered rock in THs-4, -6 and -7 to be part of the pre-basalt marine sedimentary strata (Tms, Figure 8). The Tms were mapped as extending into the channel downstream of the site (Figure 8).

The geologic mapping, area roadcuts and excavations, and historic aerial photographs, indicate that the site is underlain by bedrock consisting of Columbia River Basalt west of the Battle Creek fault and either basalt or pre-basalt sedimentary rock east of the fault (Figure 8). The top of the Basalt is decomposed to severely weathered, but it is still highly competent material. The bedrock on the slopes is typically covered by more than 6 ft of residual soils.

The area south of the site mapped as Qls (old landslide) is geomorphically continuous with the old alluvium (Qoal) stream terrace. It is possible that the terrace south of the site is actually old landslide. However, our review of the LIDAR, aerial photos, and samples from the same geomorphic terrace show no indication of a slope failure. We also know that deposits similar to the high-water / flood silts from TH-2 have been misinterpreted as landslides because of the presence of wood and leaf fragments.

Even though the soils have not failed, they compress and spread under applied loads. Consequently, we recommend that foundations be placed on competent material. Foundations and retaining walls should be designed by a qualified professional to withstand forces from lateral loads from earthquakes.

On slopes cuts higher than 4 ft and steeper than 1 V:2H, and fills more than 2 ft thick, should be designed by a qualified professional and the design reviewed by a geotechnical engineer. Walls, including retaining walls or foundation walls higher than 4 ft, should also be designed by a qualified professional and the design reviewed by a geotechnical engineer.

Additionally, we recommend against infiltration of large volumes of water into the small volumes of ground, particularly during intense rainfall events such as those noted above. Slope failures in the Salem Hills have been caused by injection of large volumes of storm water. Consequently, it is our opinion that surface runoff from roofs and pavements should be routed to the drainage or routed and dispersed over a broad area to simulate natural conditions. If it is found necessary to dispose of large amounts runoff to the soil, the location and method should be thoroughly evaluated by a qualified professional.
